***DOE/ID-10989
Revision 0
March 2006***

***Site PBF-34 Track 1 Decision Documentation
Package, OU 10-08***

Site Description: Abandoned Debris Located Near the MWSF

Site ID: PBF-34

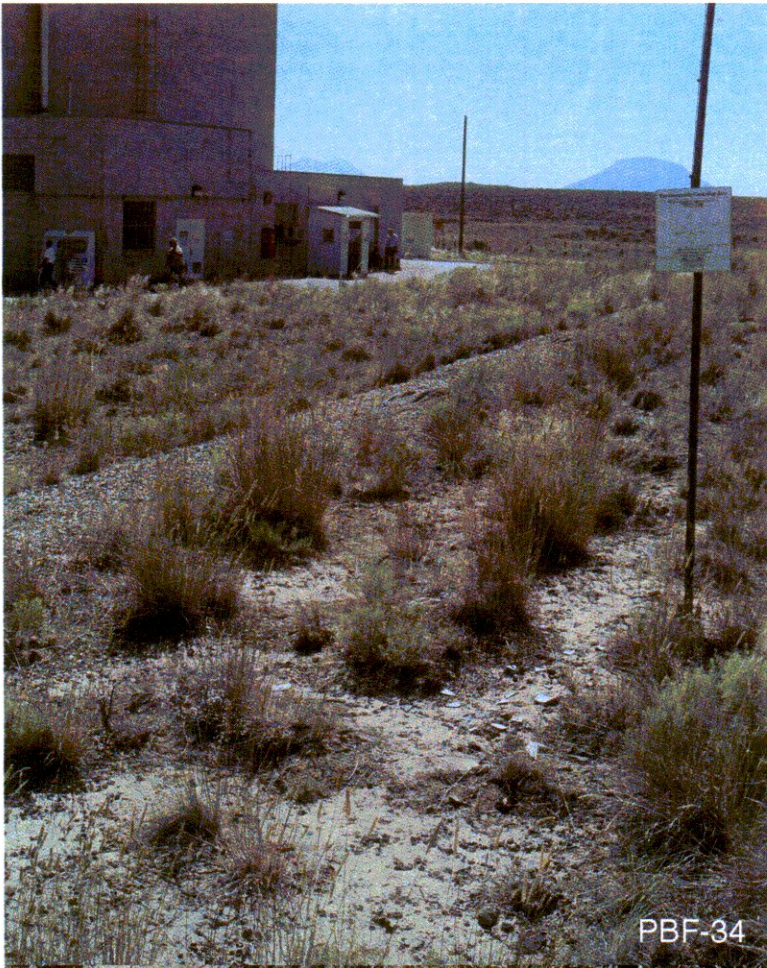
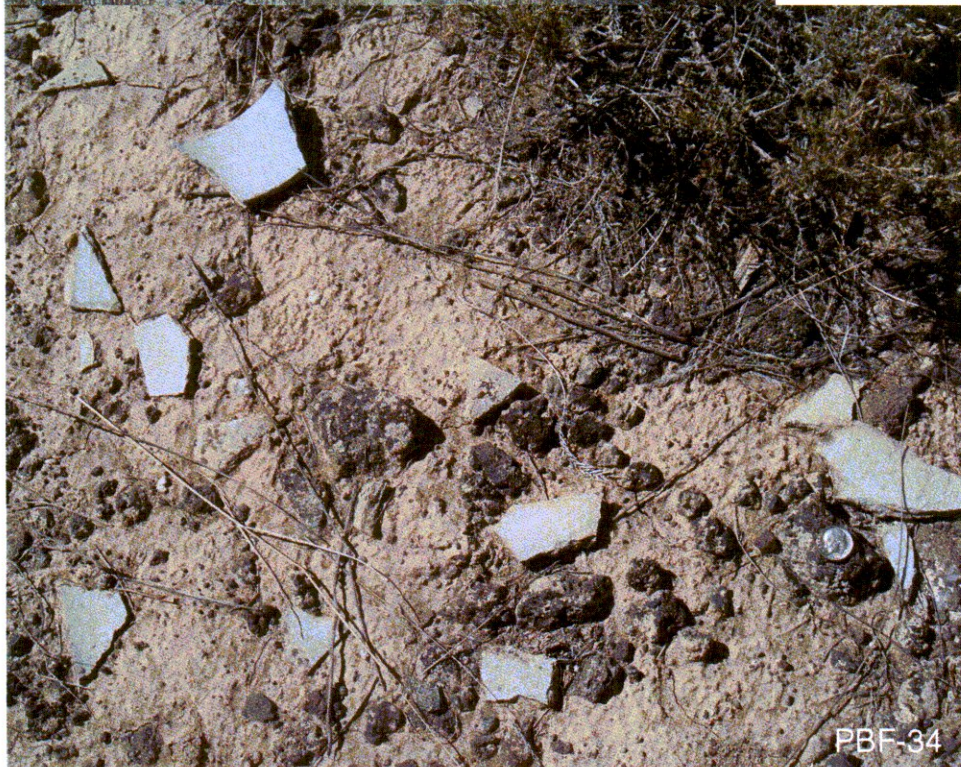
Attachment For Site PBF-34

Site PBF-34 consists of a small volume of asbestos-containing concrete (transite) pipe pieces, laying on the ground surface, about 150 ft west of the Mixed Waste Storage Facility (MWSF) at the Power burst Facility (PBF) area. The MWSF was originally the Special Power Excursion Reactor Test No. IV (SPERT-IV) facility.

Photographs indicate that the soil is not stained or discolored and vegetation near the debris is well established.

Site investigations and photographs indicate that the debris is scattered across an area approximately 10 X 10 feet.

No action is recommended.

The asbestos reinforced concrete pipe at PBF-33 was determined to be friable and is probably due to weathering. It is reasonable to assume this pipe also will weather and will become friable over time. The State believes the asbestos reinforced pipe should be removed from the site and disposed at an appropriate onsite landfill. This action can proceed without initiating a Track 2 investigation.
